Starter Warranty Approval Criteria

Starter Rejection Criteria

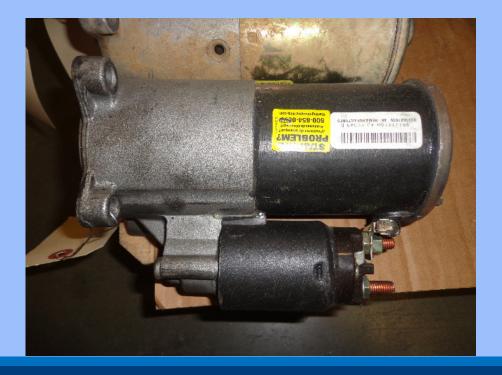
Non WAI product

Returned unit must be properly identified with original WAI labels, and date codes. In special circumstances, if original labels are missing, unit must be clearly identified with attached tag containing WAI part number, and date code of product.

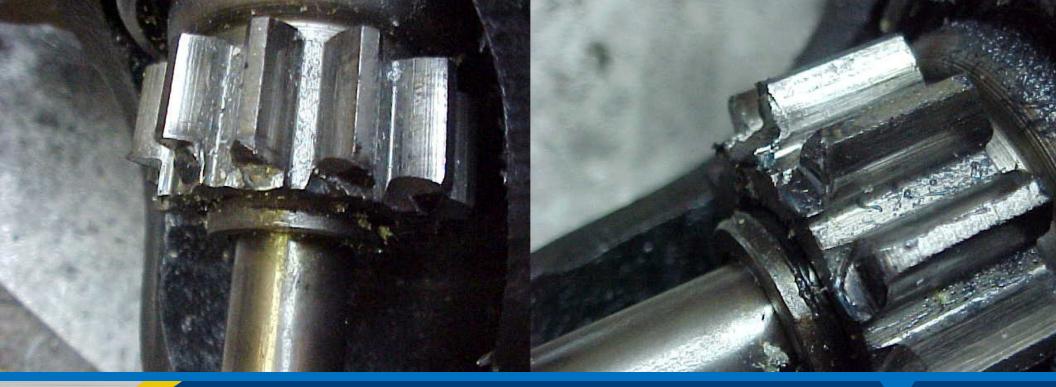
Improper use of product

Milled Pinion - Starter Drive engaged with running Ring Gear.

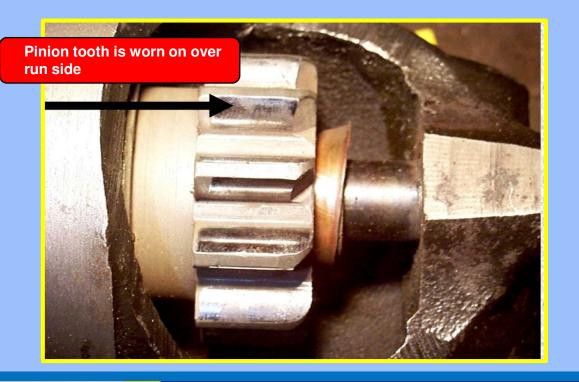
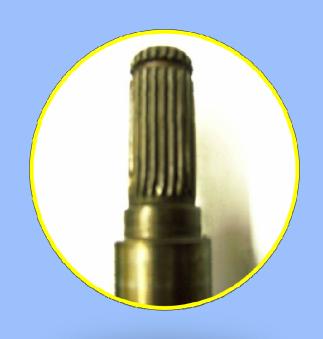
Improper use of product (Engine Rock Back)

This occurred when the starter drive stayed engaged due to a mechanical interference between the pinion and the ring gear, or as a result of Engine Rock Back. It will cause the damage to the spline or even shaft fracture. In more severe cases the nose of the DE Housing may fracture.

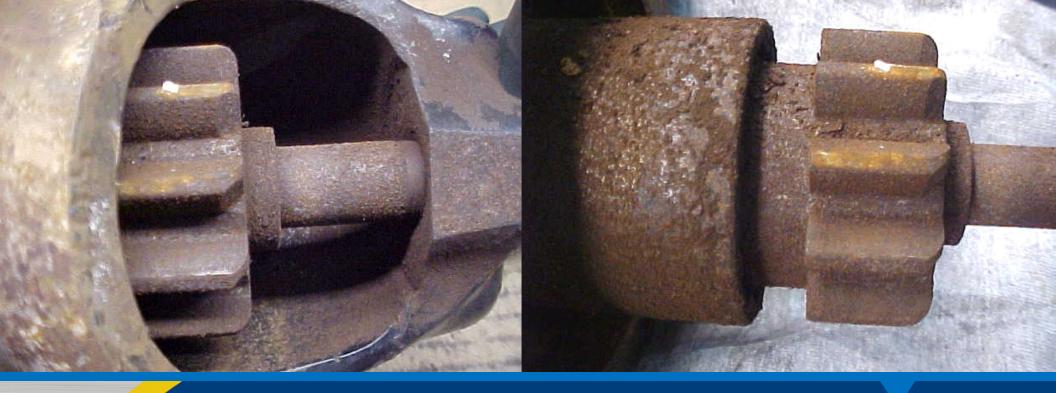
Improper use of product

Drive sticks and is difficult to move. This is caused by high humidity level in flywheel housing due to improper venting/draining forming a corrosive environment, possibly in combination with corrosive agents such as road salt. This causes extreme corrosion on the armature shaft and drive assembly increasing friction and preventing free-drive movement. Repeated starting attempts cause discoloration on solenoid coils or cause them to burn open. If the starter is located low on the engine with the nose housing opening facing up, the situation may be more aggravated.

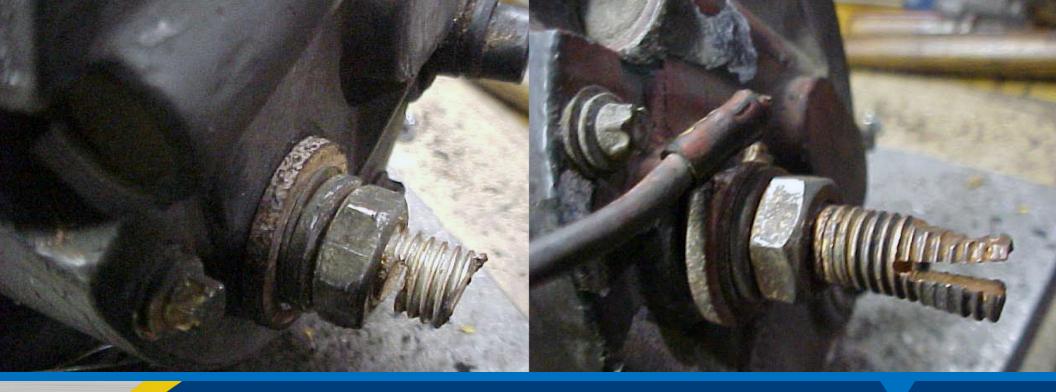
Damage to product (1)

Evidence of mechanical damage to the external components.

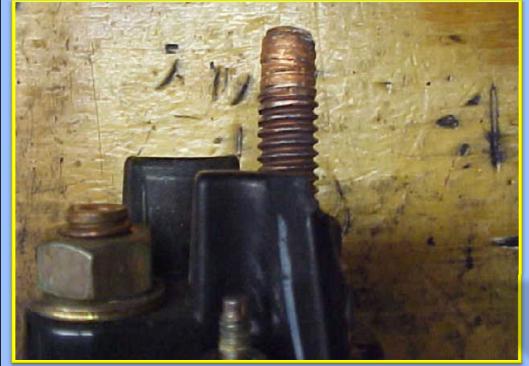
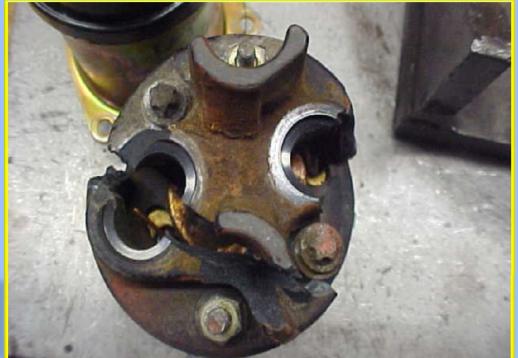
Damage to product (2)

Evidence of mechanical damage to the external components.

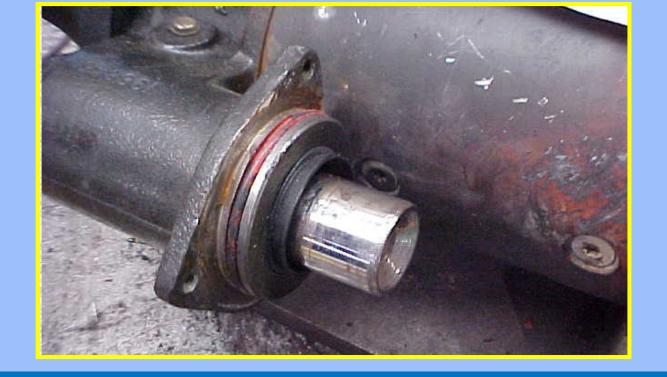
Alteration to product

Physical evidence of disassembled or modified unit.

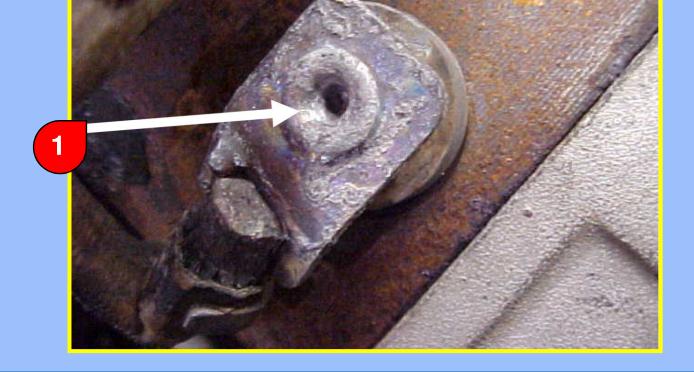
Improper use of product (1)

1- Extreme heating melted solder connection to Motor Field Terminal.

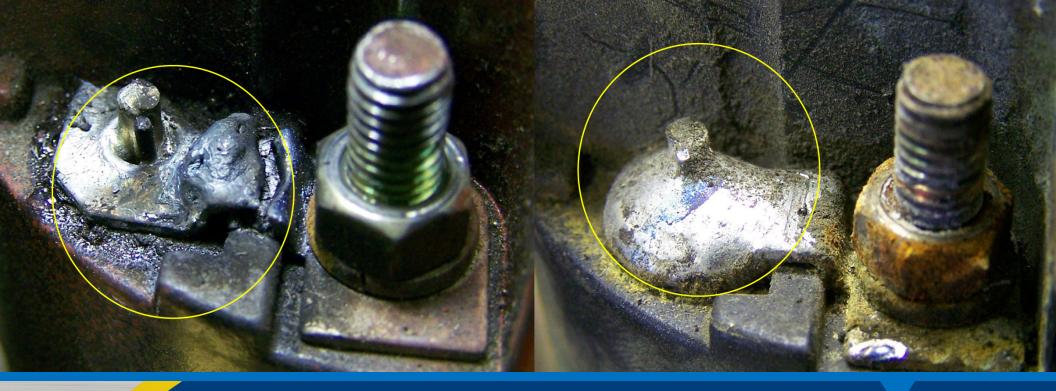
Improper use of product (2)

Prolonged power supplied to the pull-in coil is caused by damaged ring gear on engine or attempted engagement into running engine.

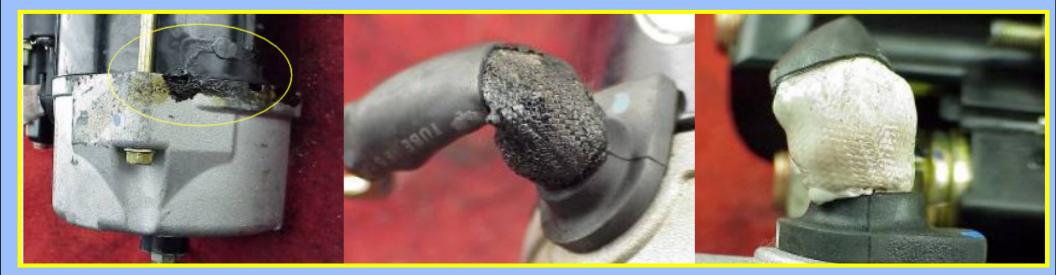
Improper use of product (3)

Melted varnish will flow from the starter and become black from heat.

Motor strap insulator discolored by over-crank.

Non-discolored motor strap insulator for reference. Insulator color may vary.

Over-cranked starters are not covered by warranty, because the operator caused the failure by the holding the ignition switch for too long when the engine would not start.

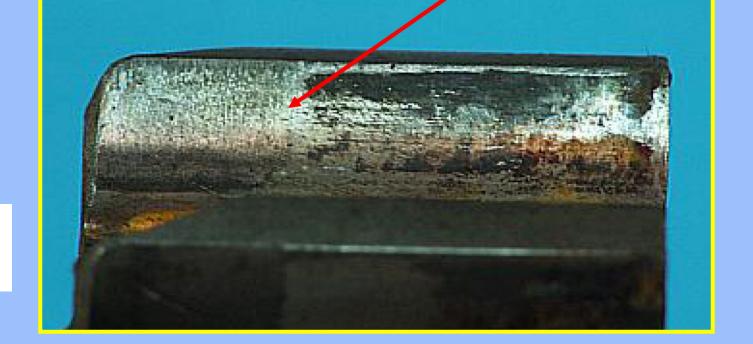
Improper use of product (4)

4-6 mm wear pattern from the face of the Pinion. Normal Pinion engagement depth into a ring gear is 17.4mm

Wrong ring gear axial position due to wrong or no spacer installed.

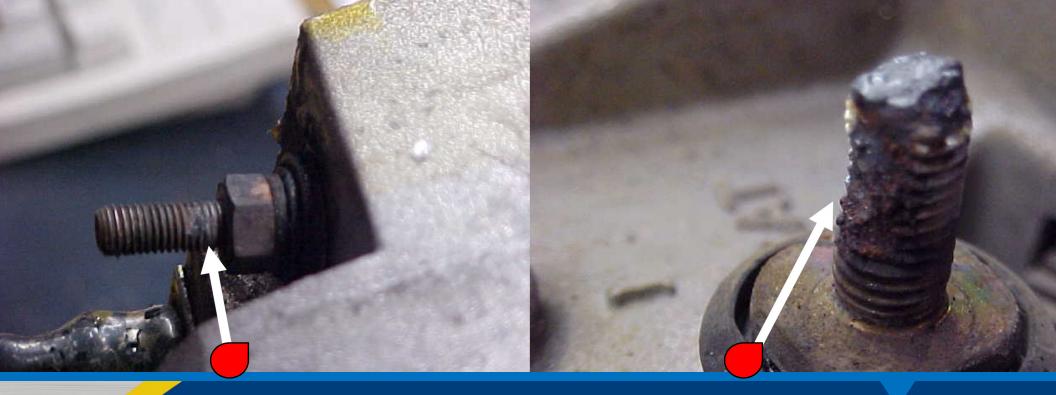
Damaged Product (8)

Damaged terminals caused by heavy arcing present from loose cable terminal. Result of improper installation or insufficient vehicle maintenance.
