Starter Warranty Approval Criteria

Starter Rejection Criteria

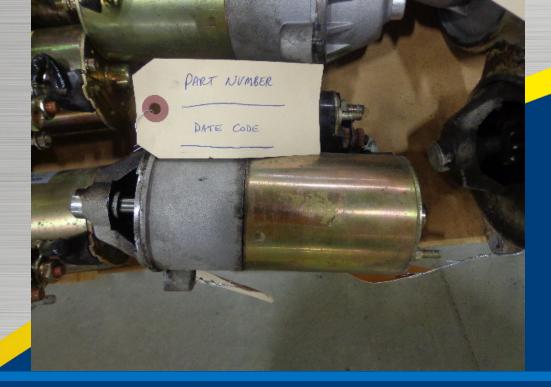
Non WAI product

Returned unit must be properly identified with original WAI labels, and date codes. In special circumstances, if original labels are missing, unit must be clearly identified with attached tag containing WAI part number, and date code of product.
